**NBSIR 80-2039**

**Report No. 10**

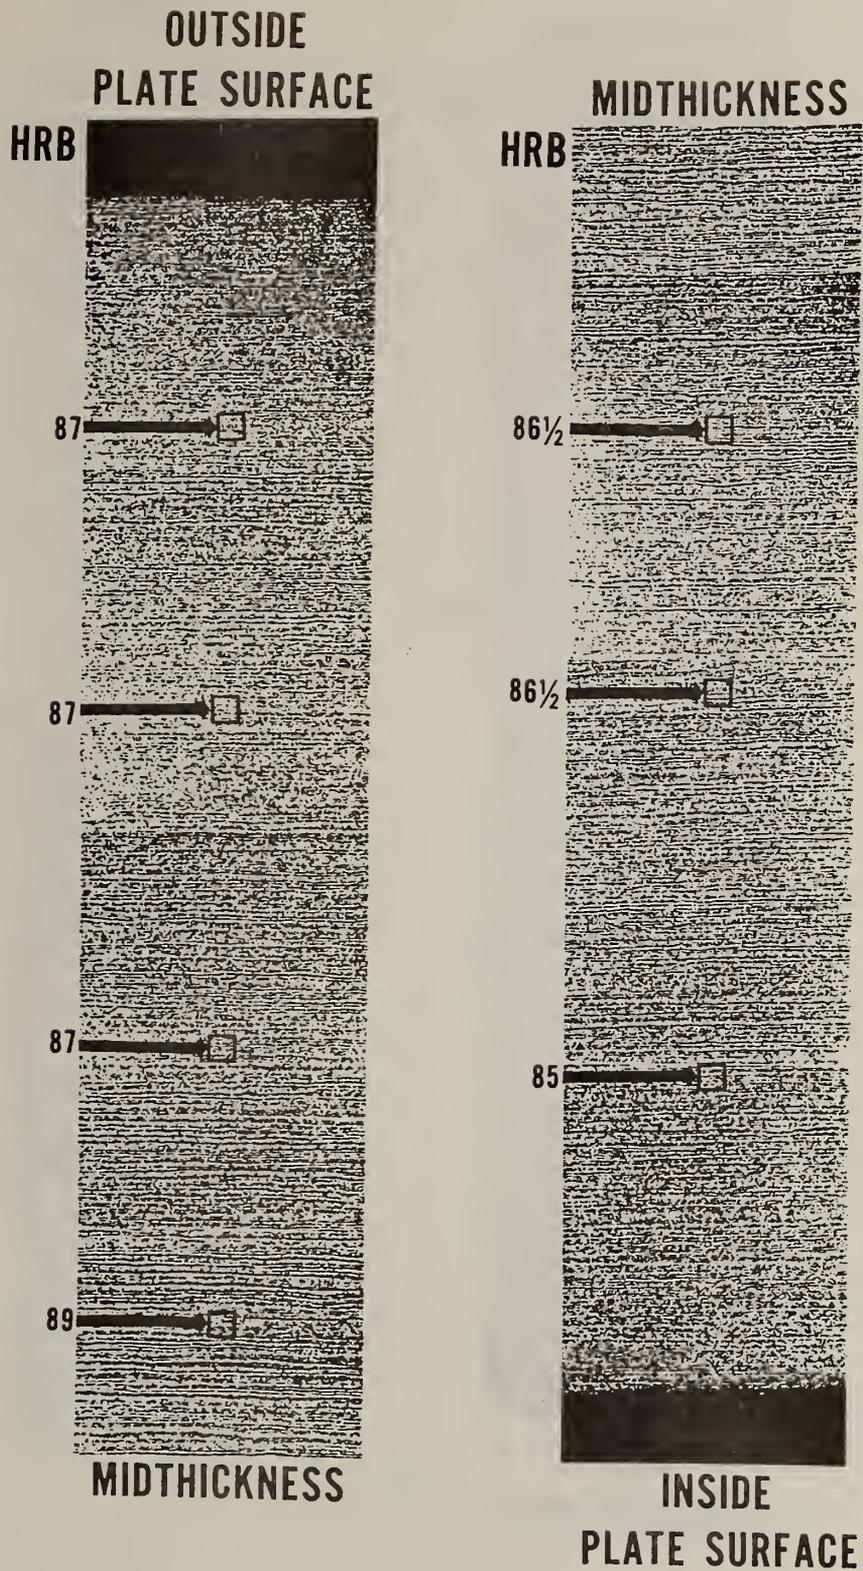
Figure 6. Montage of Microstructure Through Cross-Section of the Plate Sample from Tank Car UTLX 38498

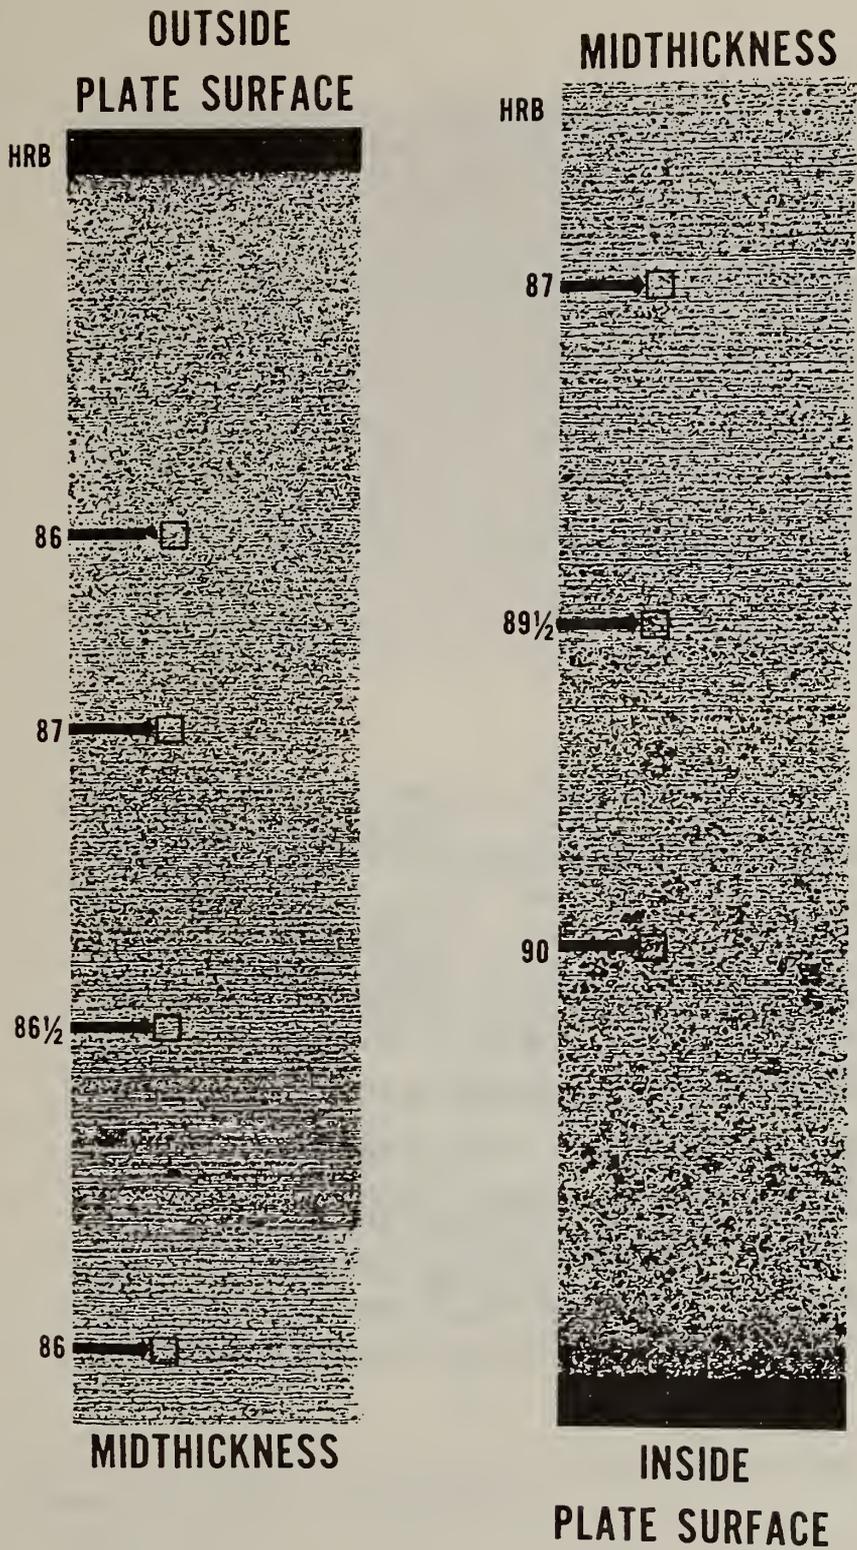
Figure 7. Montage of Microstructure Through Cross-Section of the Plate Sample from Tank Car GATX 93412

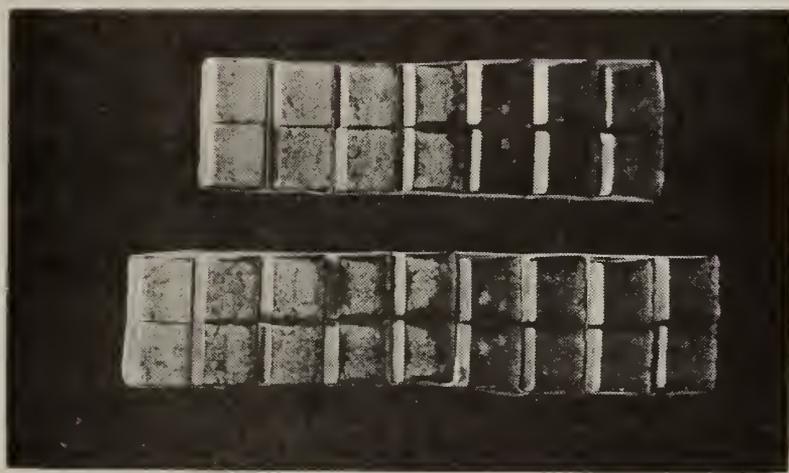
Sample No.	Energy Abs. (ft-lb)	Test Temperature
GT27	3	-120 F
GT32	10	- 80 F
GT33	12	- 60 F
GT1	19 1/2	- 40 F
GT15	25	0 F
GT35	34 1/2	20 F
GT10	37 1/2	40 F
GT11	37	80 F
GT6	37 1/2	100 F
